SAFETY INSPECTION REPORT OF LAKE GENEVA DAM ID #617

Prepared for:
LAKE GENEVA ASSOCIATION
1114 E. Geneva Drive
City of DeWitt, MI

Submitted by:
WILCOX PROFESSIONAL SERVICES, LLC
111 W. Edgewood Blvd., Suite 7
Lansing, MI 48911

Report Date: May 2012

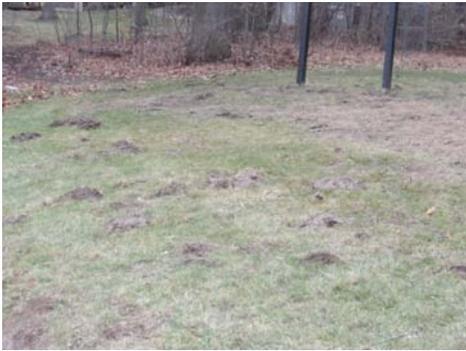
within the top surface of the dam as shown in the picture to the left.

1. Check for burrowing animals and remove if present. Fill and compact any damaged areas by the animals. **Moles seem to be present**
