SAFETY INSPECTION REPORT OF LAKE GENEVA DAM ID #617

LAKE GENEVA ASSOCIATION
1114 E. Geneva Drive, City of DeWitt
Clinton County, Michigan
A Significant Hazard Dam

1/22/2021

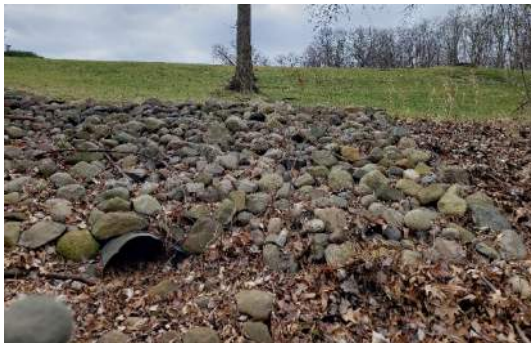
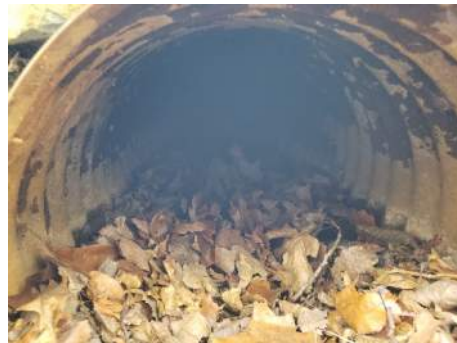
1. Redistribute the riprap in front of the discharge pipe along the downstream end so the full capacity of the pipe is available, and it is readily visible and accessible.

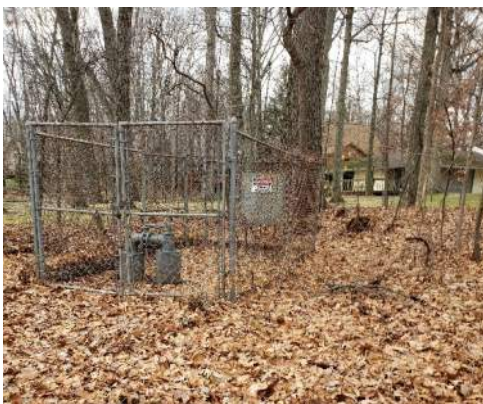
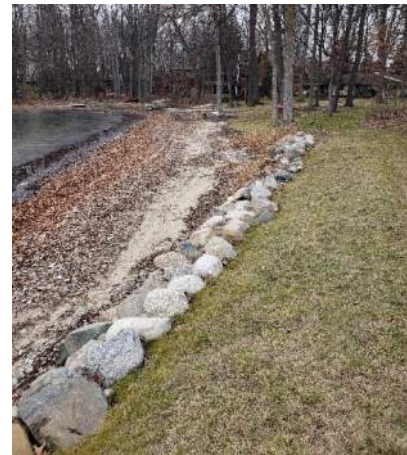
3. Preserve the area around the pump enclosure and discharge outlet along the west end of the dam clear and open so they are readily visible and accessible at least from the dam side. (east side)

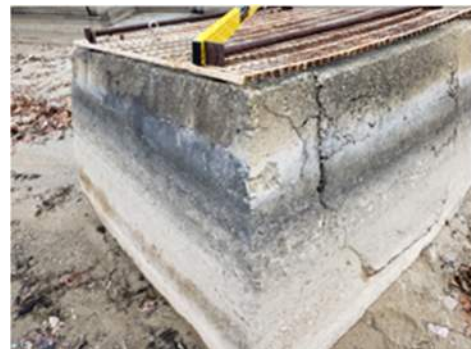
4. The concrete spalling and cracks

along the south west corner of the outlet structure seem to be worsening. It is recommended that loose and cracked concrete be removed and repairs be made when feasible.

fractured concrete should be removed and cleaned out before new epoxied concrete is used to stabilize the repair areas. However, there is no significant indication of structural instability. If work cannot be completed in timely fashion, the structure should be inspected on a regular basis after each freeze and thaw cycle to ensure that no concrete spalling or further deterioration has taken place.

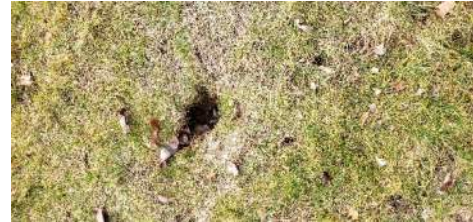
5. There was evidence of some mole activities along the top of the dam that need to be monitored and mitigated so it is not a potential hazard.
6. Establish a regular inspection schedule to check for obvious damage or deficiencies related to the above-mentioned elements.

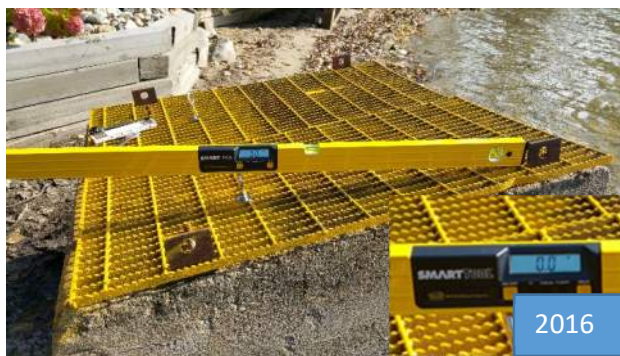
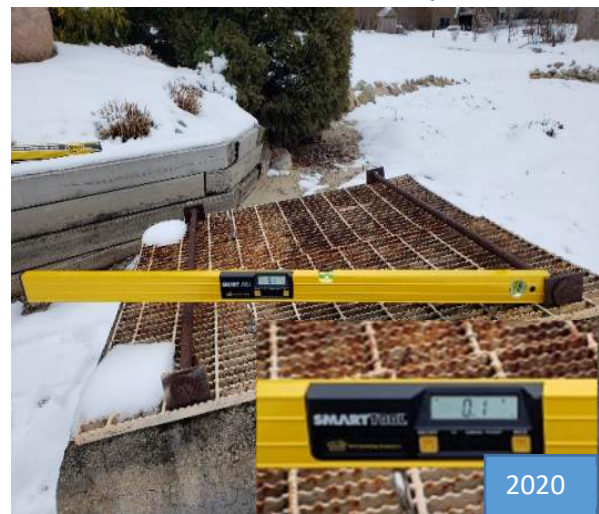
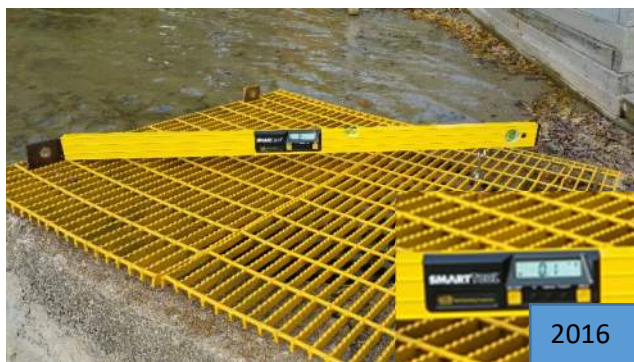
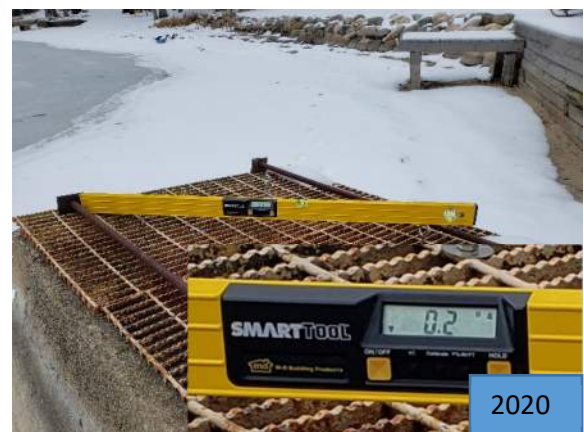
7. Using on the previously installed stainless steel eyelids, it seems that the structure has settled very slightly since the last inspection. The CMP structure and pipe do not seem to have been affected or show any damage with respect to each other but there is still no knowledge of the condition of the outlet pipe. It is recommended that if the system have been televised that a qualified professional review the footage as to assess the viability of the outlet pipe.

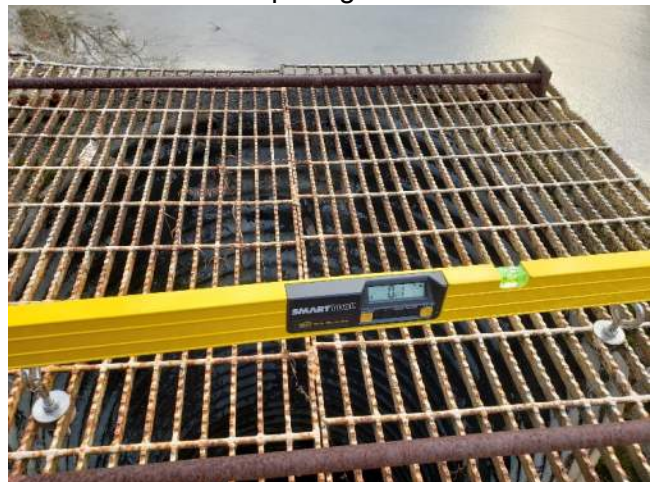
In order to establish a base layout of the structure, a digital level was used to record the differential slope between all the corners of the structure using the concrete structure with the metal grate. It was confirmed that the southwest corner is about 6-7” higher than the northeast corner of the structure. Two stainless steel eyelids were installed during the previous inspection along the north end of the structure at an elevation that is similar to the elevation of the southwest corner in order to establish a level surface. The measurements taken during this inspection show a slight settlement in the northeast corner.

These controls will continue to be used during future monitoring to assess potential settlements if any. Further monitoring should be performed between inspections.

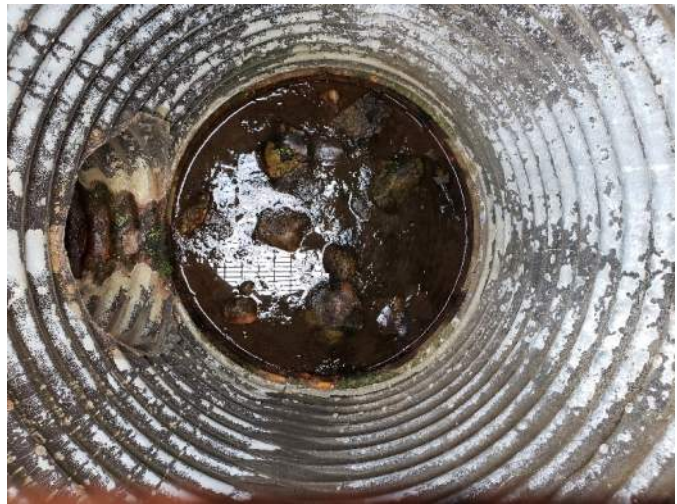
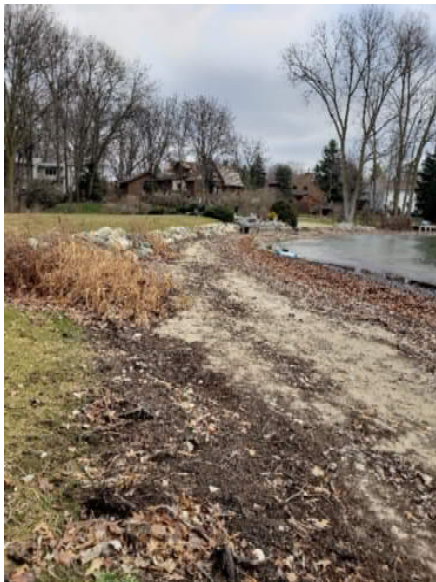
The 36-inch diameter CMP is in good condition. Where exposed, the bituminous coating has mostly worn away; however, the pipe shows only minor signs of corrosion and is in good condition. The outlet control pipe is a 21-inch bituminous coated CMP and is in good condition. The bituminous coating on this pipe is also worn away where exposed. Leaves and sediments in front of the outlet pipe on the downstream end should be cleaned from the pipe, so the pipe outlet is fully available.

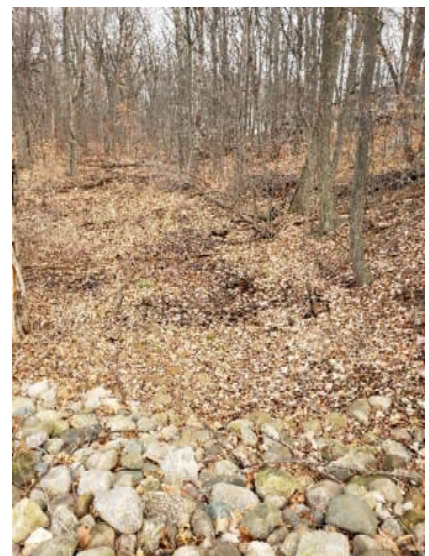
The downstream bank has been cleaned and maintained since our last inspection and seems to be in good shape. The downstream slope was 4 horizontal to 1 vertical for the first 18 feet, then 2.5 horizontal to 1 vertical for the remainder to the toe in the vicinity of the outlet pipe. There were no indications of seepage or erosion at the toe of the slope but riprap stones need to be removed/lowered in front of the outlet pipe so it is exposed and can be fully useable when needed. The receiving channel appeared adequate to accept normal discharge from the dam.
