SAFETY INSPECTION REPORT OF LAKE GENEVA DAM ID #617

Prepared for:
LAKE GENEVA ASSOCIATION
1114 E. Geneva Drive
City of DeWitt, MI

Submitted by:
WILCOX PROFESSIONAL SERVICES, LLC
111 W. Edgewood Blvd., Suite 7
Lansing, MI 48911

Report Date: May 2012

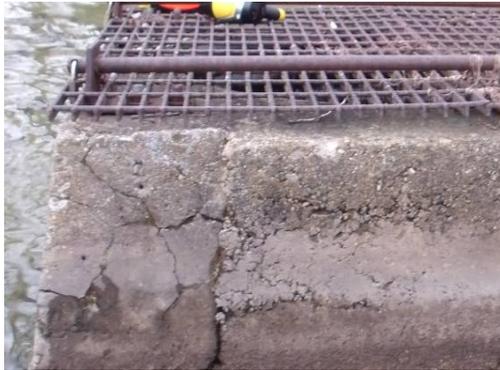
4. Establish a regular inspection schedule to check for obvious damage or deficiencies related to the above mentioned elements.
5. The cracks along the south west corner of the outlet structure still seem stable with minor change. It is recommended that loose and cracked concrete be removed and repairs be made when feasible.

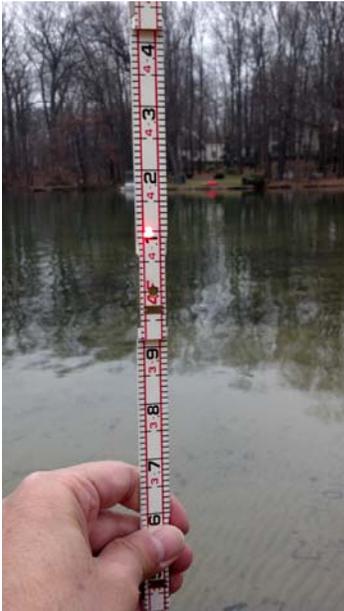
The lake level on December 19, 2011, the date of our inspection, was 18.5” below the defined bench mark noted above or 98.458’ with no flow passing through the structure. This roughly indicates that the water level is 4.1 feet below the top of the dam as shown in the picture to the left. The downstream invert of the receiving channel was assumed to be the same or 86.5 producing a normal head of 11.958 feet.

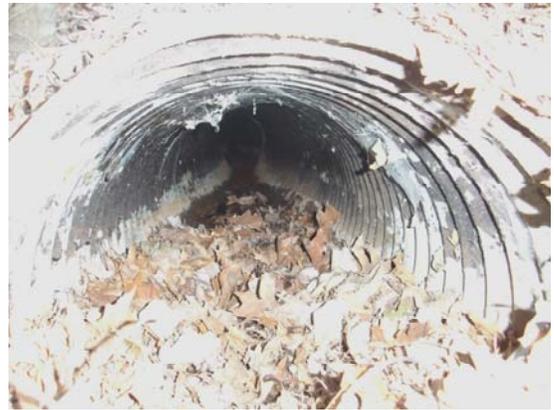
The 36 inch diameter CMP is in good condition. Where exposed, the bituminous coating has mostly worn away; however, the pipe shows only minor signs of corrosion and is in good condition. The outlet control pipe is a 21 inch bituminous coated CMP and is in good condition. The bituminous coating on this pipe is also worn away where exposed. Riprap in front of the outlet pipe seems to block part of the pipe and impede some flows from draining. The riprap should be lowered to within 1/2" below the invert of the outlet pipe.

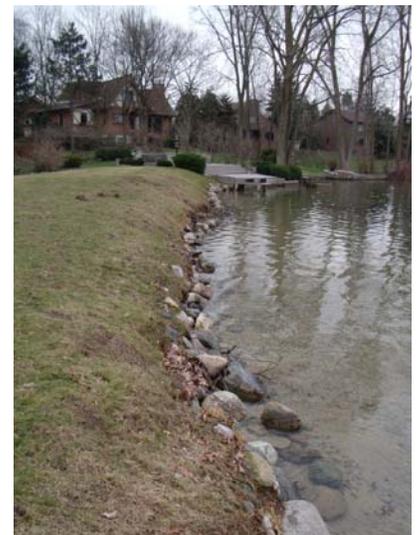
The upstream embankment was for the most part grass covered for the majority of its length. On the right side, a homeowner has constructed a wooden deck and wooden seawall in front of the structure. These features obscure the observation of the embankment and could hinder access to the control structure for future maintenance projects, but are of no immediate concern. Stone riprap adjacent to the wooden seawall seems to extend left along the majority of the embankment. The bank has eroded somewhat as noted before and needs to be re-stabilized. Upstream slope was about 2 horizontal to 1 vertical.

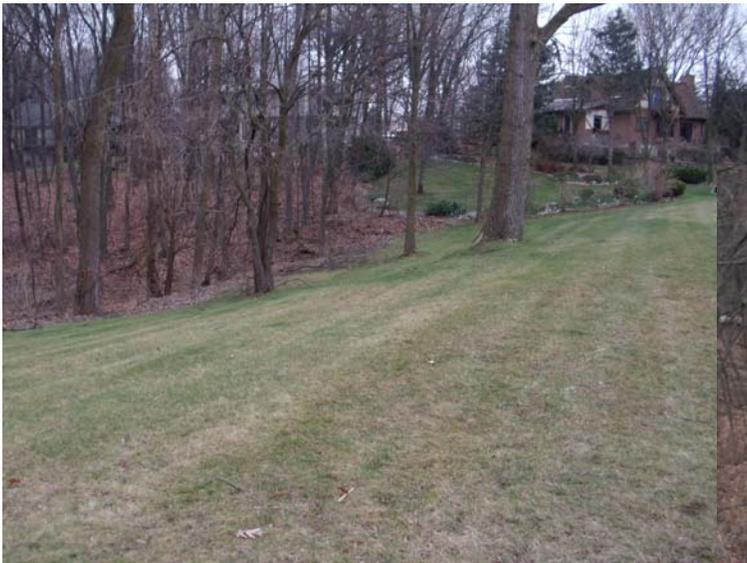
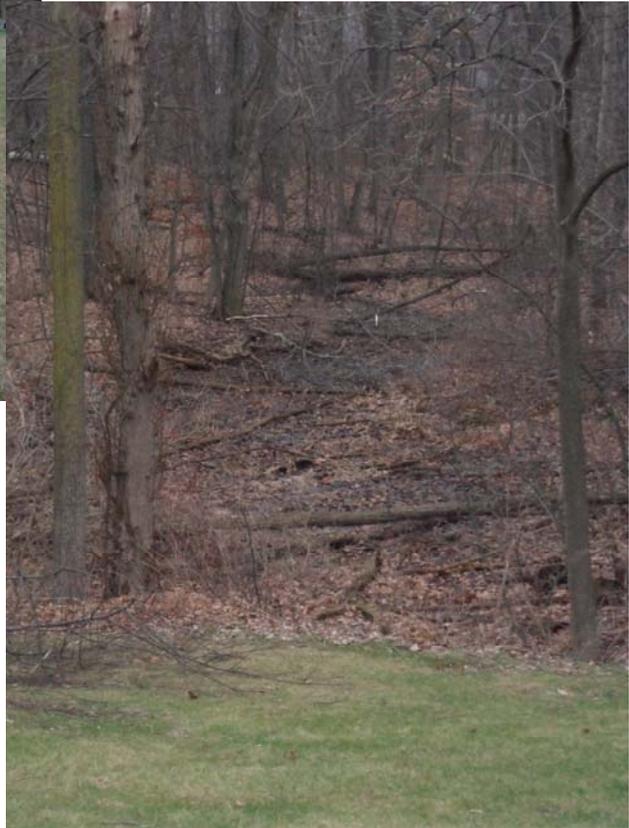
There were no indications of seepage or erosion at the toe of the slope but leaves and grass clippings have been disposed near the outlet

pipe which obstructs any visible views of possible issues and it is recommended that those be removed and placed further to the left on the flatter section of the dam. Riprap materials seem to be present at the end of the discharge pipe but are mostly covered with heavy brush material.
