SAFETY INSPECTION REPORT OF LAKE GENEVA DAM ID #617

LAKE GENEVA ASSOCIATION
1114 E. Geneva Drive, City of DeWitt
Clinton County, Michigan
A Significant Hazard Dam

1/22/2021

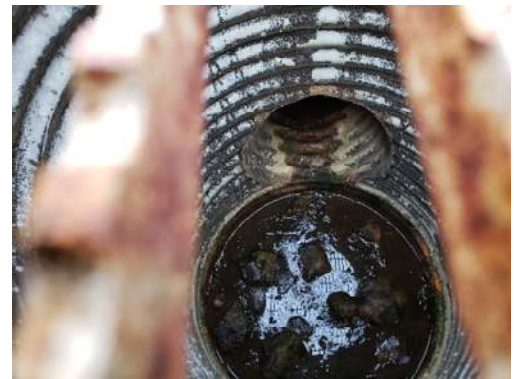
The dam consists of an outlet control structure and approximately 125 feet of earthen embankment. Level is controlled by a 5' long vertical 36" bituminous coated corrugated metal pipe that is encased in concrete. The concrete encasement forms a 4' x4' square structure. There is a notch formed in the concrete that appears to be constructed for the purpose of stop planks, however, the pipe was never removed to allow flow of water. The outlet pipe is a 21-inch bituminous coated corrugated metal pipe. The 21-inch pipe discharges to the unnamed tributary. There are no drawdown facilities, gates or stop planks.

Inspection of the outlet pipe and the internal of the structure show no obvious signs of settlement or leakage which is a positive sign.

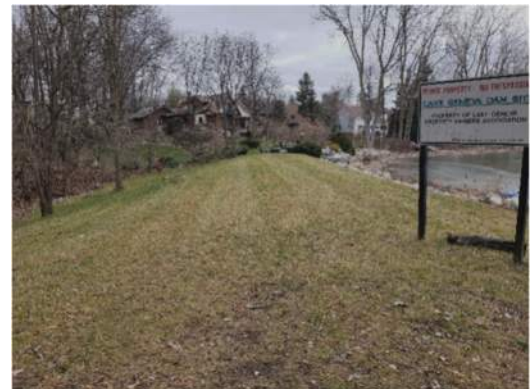
The earthen embankment is approximately 125 feet in length. The crown varies from 16 to 18 feet wide and the upstream and downstream slopes are generally 2 horizontal to 1 vertical and 4 horizontal to 1 vertical respectively.

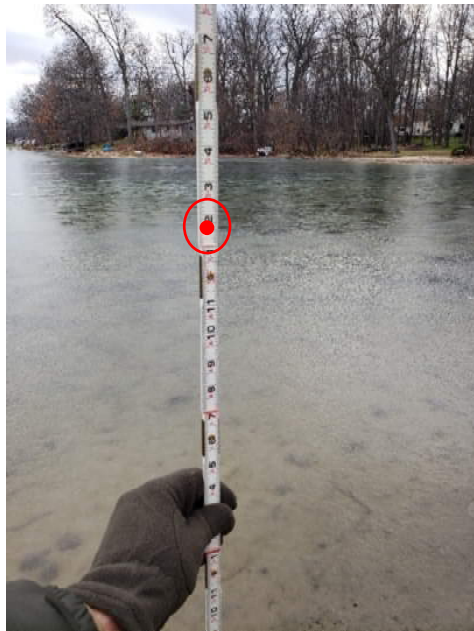
The lake level on December 12, 2020, the date of our inspection, was 31” below the defined benchmark noted above or 97.416’ with no flow passing through the structure. This roughly indicates that the water level is 5’2” below the top of the dam as shown in the picture to the left. The downstream invert of the receiving channel was assumed to be the same or 86.5 producing a normal head of 10.917 feet. It was also noted during our inspection that both augmentation wells that supplement the lake level were off.
